AVIATION OCCURRENCE REPORT

RISK OF COLLISION BETWEEN:

DELTA IR LINES
LOCKHEED L-1011 N1739D and
CONTINENTAL AIRLINES
BOEING 747-200 N608PE
NORTH ATLANTIC 52°14'N 34°00'W
08 JULY 1987

REPORT NUMBER 87-A74947

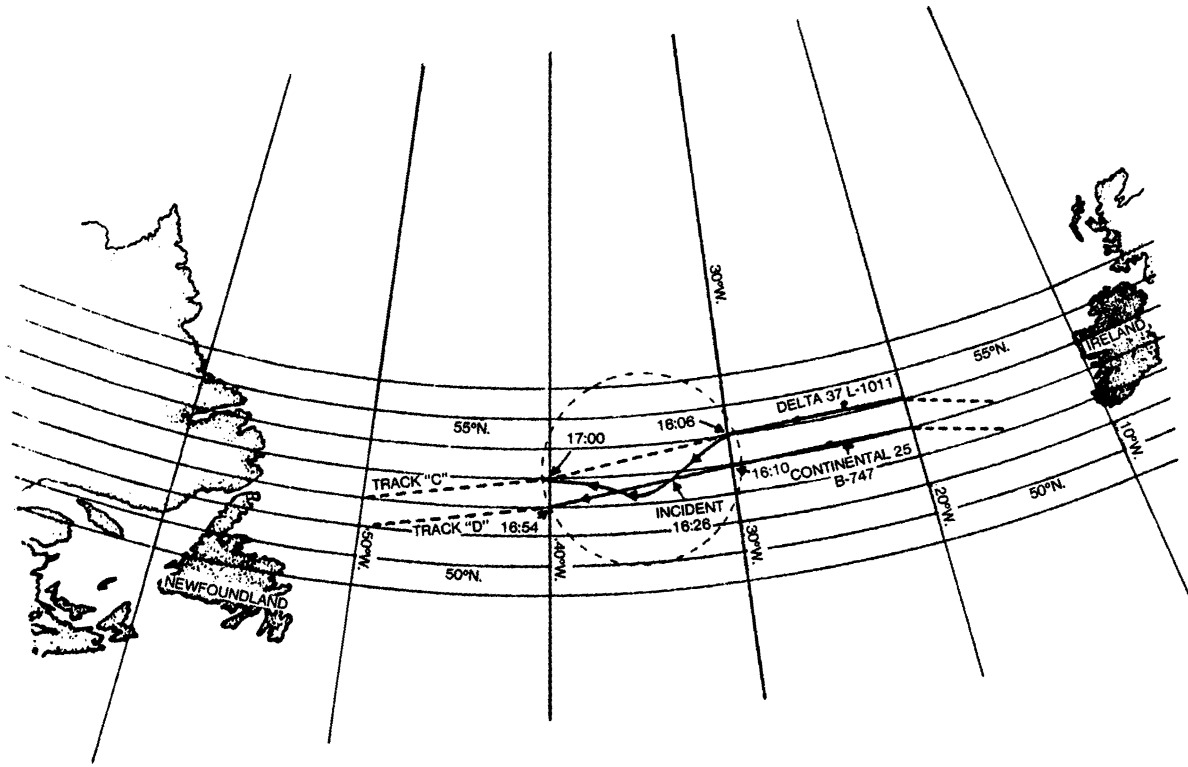
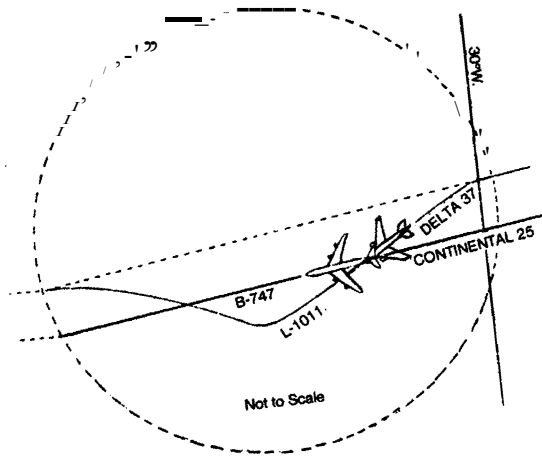
figure 1.1. flight PathS - Delta 37 Continental 25

At 30 degrees west longitude, Delta 37 began deviating to the south of its assigned track and closed laterally with Continental 25 (see Figure 1.1.). Delta 37's deviation continued until the aircraft crossed the assigned track of Continental 25. As Delta 37 crossed the track of Continental 25, the front half of Delta 37 passed beneath the rear fuselage of Continental 25 with less than 100 feet of vertical separation. Neither crew saw the other aircraft in time to take evasive action.

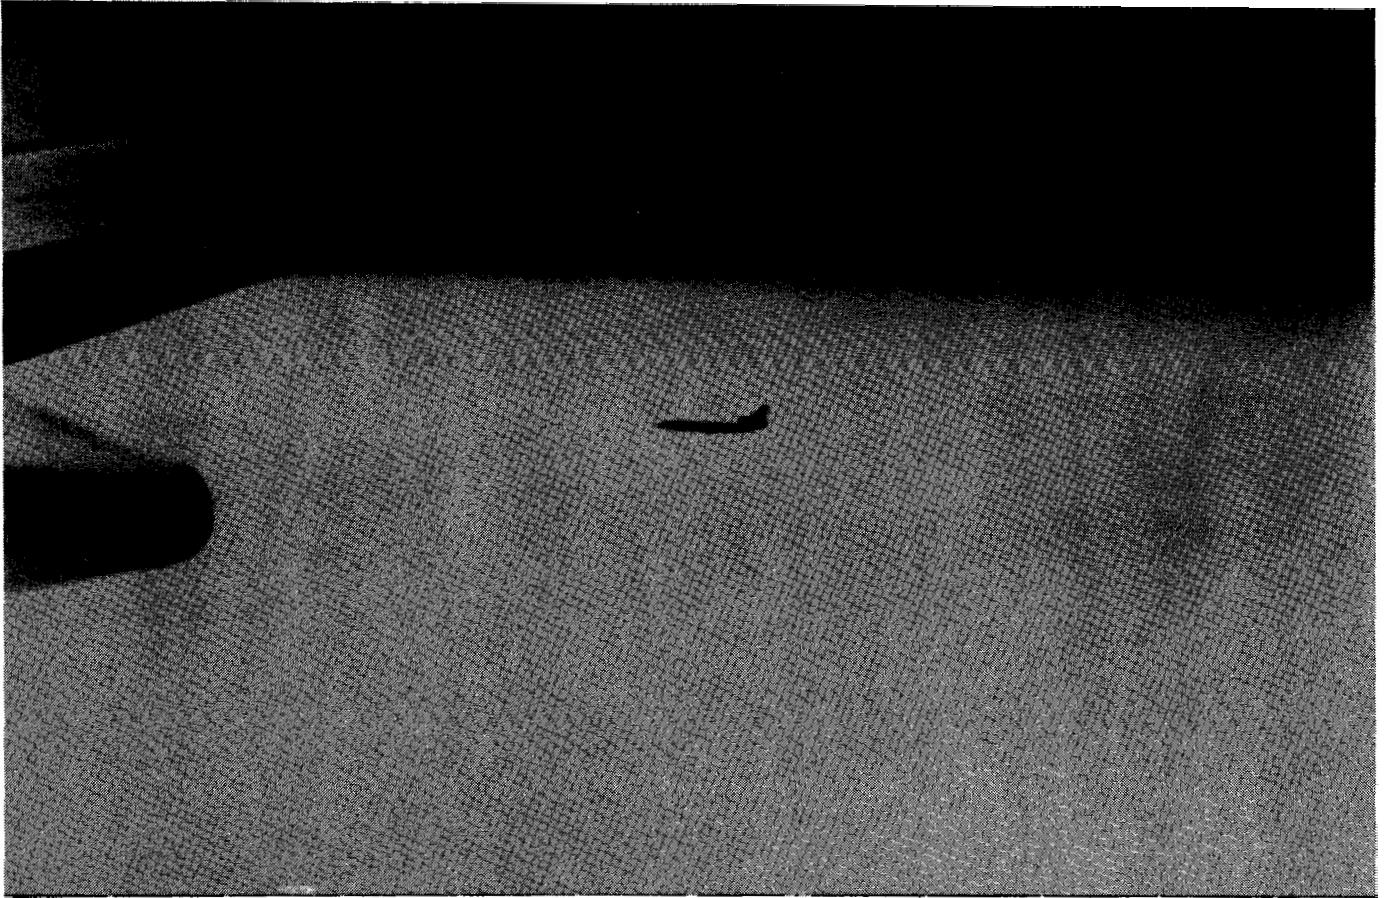
Figure 1.2. Photograph of Delta 37 Taken by Passenger
On Board Continental 25

On Continental Flight 25, the first officer was the only flight crew member who was in a position to see Delta 37; to do so he would have had to be looking to his extreme right. However, at the time of the occurrence, he was looking straight ahead until approximately three seconds before the two aircraft crossed, when he looked to his right and caught a glimpse of Delta 37. Several passengers aboard Continental Flight 25 saw Delta 37 moments before the two aircraft crossed; one passenger **was able** to photograph the Delta Lockheed L-1011 (see Figure 1.2.).
